Analysis of Damages to Boiler Screen Tubes BKZ-160-100-GM (Barnaul Boiler Plant, steam productivity 160 t/h, pressure 100 kgf/cm², Fuel: Natural Gas/Fuel Oil) after Reconstruction for Increased Steam Productivity to 210 t/h

Joint-Stock Company "I. I. Polzunov Scientific and Development Association on Research and Design of Power Equipment" JSC "NPO CKTI", St. Petersburg, Russia

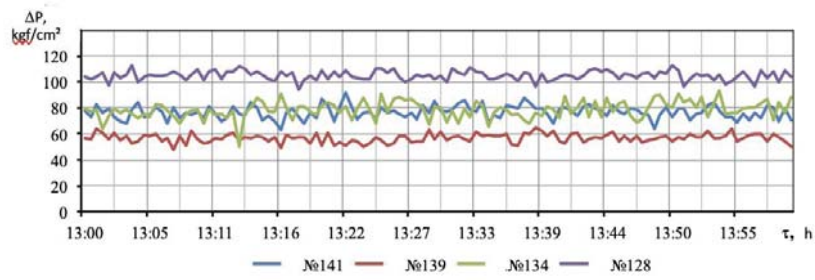
Pitot tubes at a load of 190 t/h, indicating that circulation velocities have minor structural pulsations and exhibit a stable character.

Figure 2: Dynamic pressure of Pitot tubes at a boiler load of 190 t/h and feedwater temperature of 205 °C.

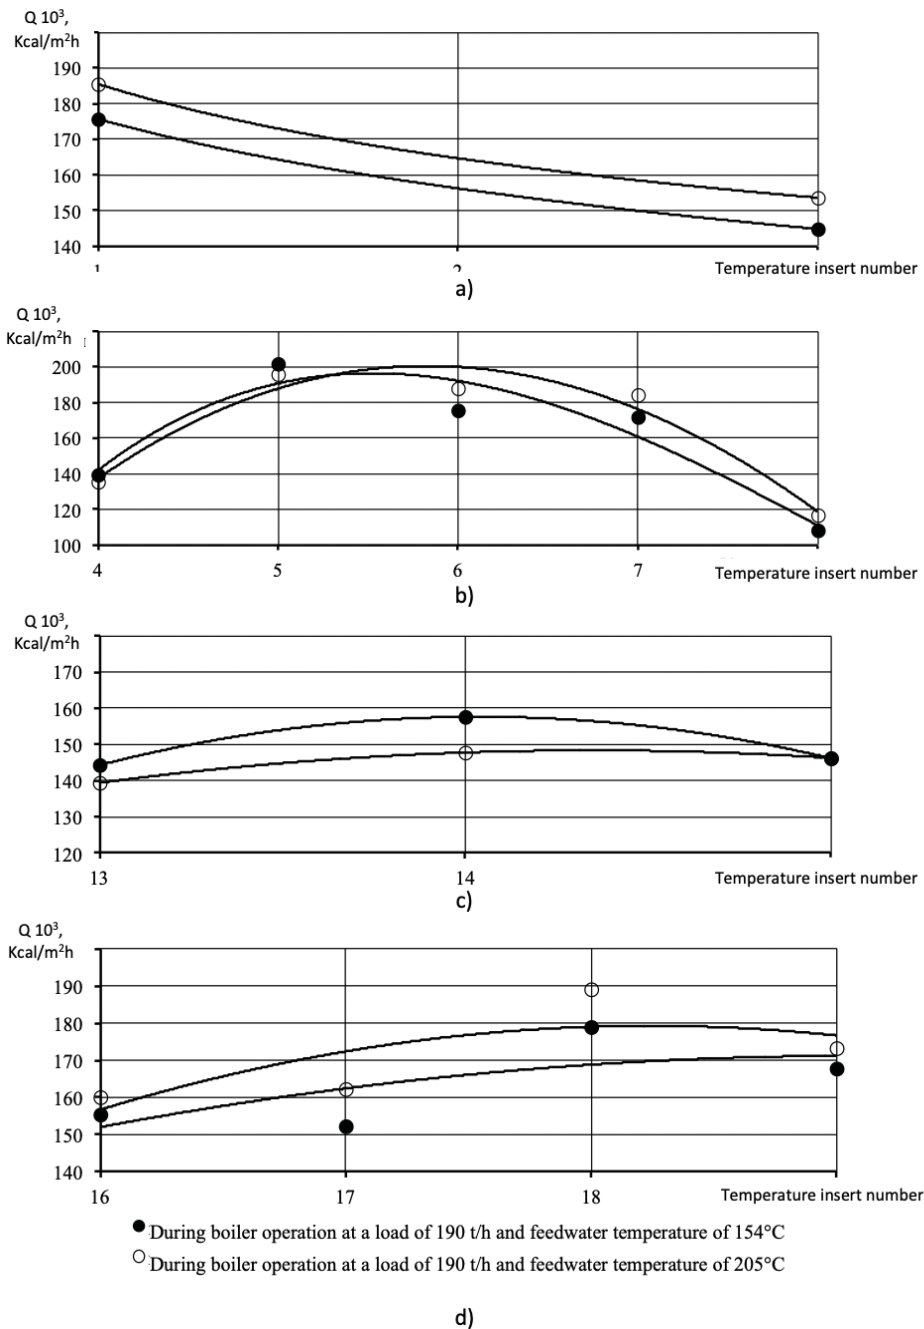
As seen in Figure 3, which illustrates the distribution of heat flows across the width of the left side screen, the maximum heat flows do not exceed 200,000 kcal/m²h. At such heat load values and measured circulation velocities, the occurrence of critical deterioration of heat transfer in the screen tubes is excluded, which is confirmed by temperature measurements on the outer surface of the screen tubes, with values not exceeding 330 °C - 345 °C.

Figure 3: Distribution of heat loads across the width of the furnace at an elevation of 8.0 m. a) Front screen; b) Right side screen; c) Rear screen; d) Left side screen.

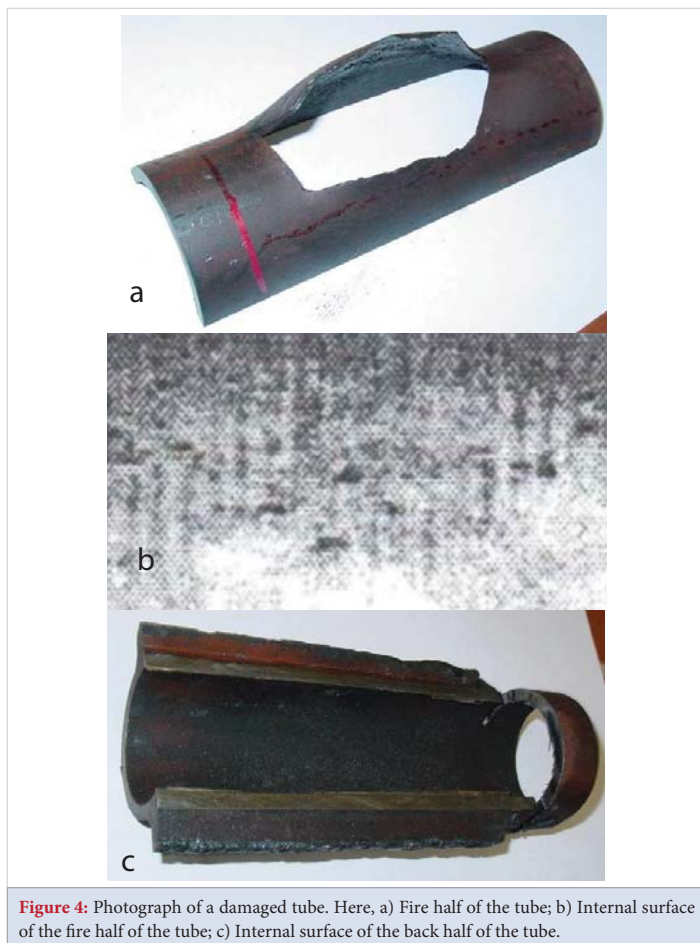
Figure 4 presents photographs of the damaged screen tube. The damage is characterized by metal rupture on the heated side. On the internal fire side of the tube, the damaged metal is subject to significant corrosion. Traces of point corrosion, in the form of ulcers with a diameter of 1.2 mm - 3 mm and a depth of no more than 0.5 mm, are observed on the internal surface of the back side of the tube.

On the internal surface of the fire half of the tube, there are dense black deposits, amounting to 176 g/m², determined by the cathodic etching method and consisting mainly of iron oxides (75% - 90% Fe₂O₃). Significant losses during annealing (up to 8%) are noted.

Internal deposits on the fire side of the tube are solid and practically cannot be removed by mechanical means, while on the back side, they are loose and easily removable by mechanical scraping.

The formation of numerous leaks, in the form of through holes with a diameter of 0.5 mm - 1.0 mm, is caused by internal corrosion of the metal due to the destruction of the protective film, resulting from the impact of aggressive boiler water. Metal overheating in the area of leaks is not observed.

The main cause of metal ruptures in the screen tube (Figure 3a), with dimensions of 120x40 mm, is metal corrosion, as well as local overheating of the wall caused by the formation of a steam layer due to the detachment of internal deposits.

Due to the difference in thermophysical properties between changed deposits and tube metal, their delamination occurred, creating a steam layer at the tube wall, where deep evaporation of salts and intensified corrosion, as well as metal overheating, took place. It is worth noting that similar types of screen tube damage were observed in boilers with direct combustion.

Therefore, a replacement of screen tubes was carried out on both side screens, totaling 14 tubes.

After the replacement of the screen tubes, no damages were observed on the reconstructed boilers.
