Analysis of Damages to Boiler Screen Tubes BKZ-160-100-GM (Barnaul Boiler Plant, steam productivity 160 t/h, pressure 100 kgf/cm², Fuel: Natural Gas/Fuel Oil) after Reconstruction for Increased Steam Productivity to 210 t/h. IgMin Res. April 15, 2024; 2(4): 218-223. IgMin ID: igmin168; DOI: 10.61927/igmin168; Available at: igmin.link/p168

Analysis of Damages to Boiler Screen Tubes BKZ-160-100-GM (Barnaul Boiler Plant, steam productivity 160 t/h, pressure 100 kgf/cm², Fuel: Natural Gas/Fuel Oil) after Reconstruction for Increased Steam Productivity to 210 t/h

Joint-Stock Company "I. I. Polzunov Scientific and Development Association on Research and Design of Power Equipment" JSC "NPO CKTI", St. Petersburg, Russia

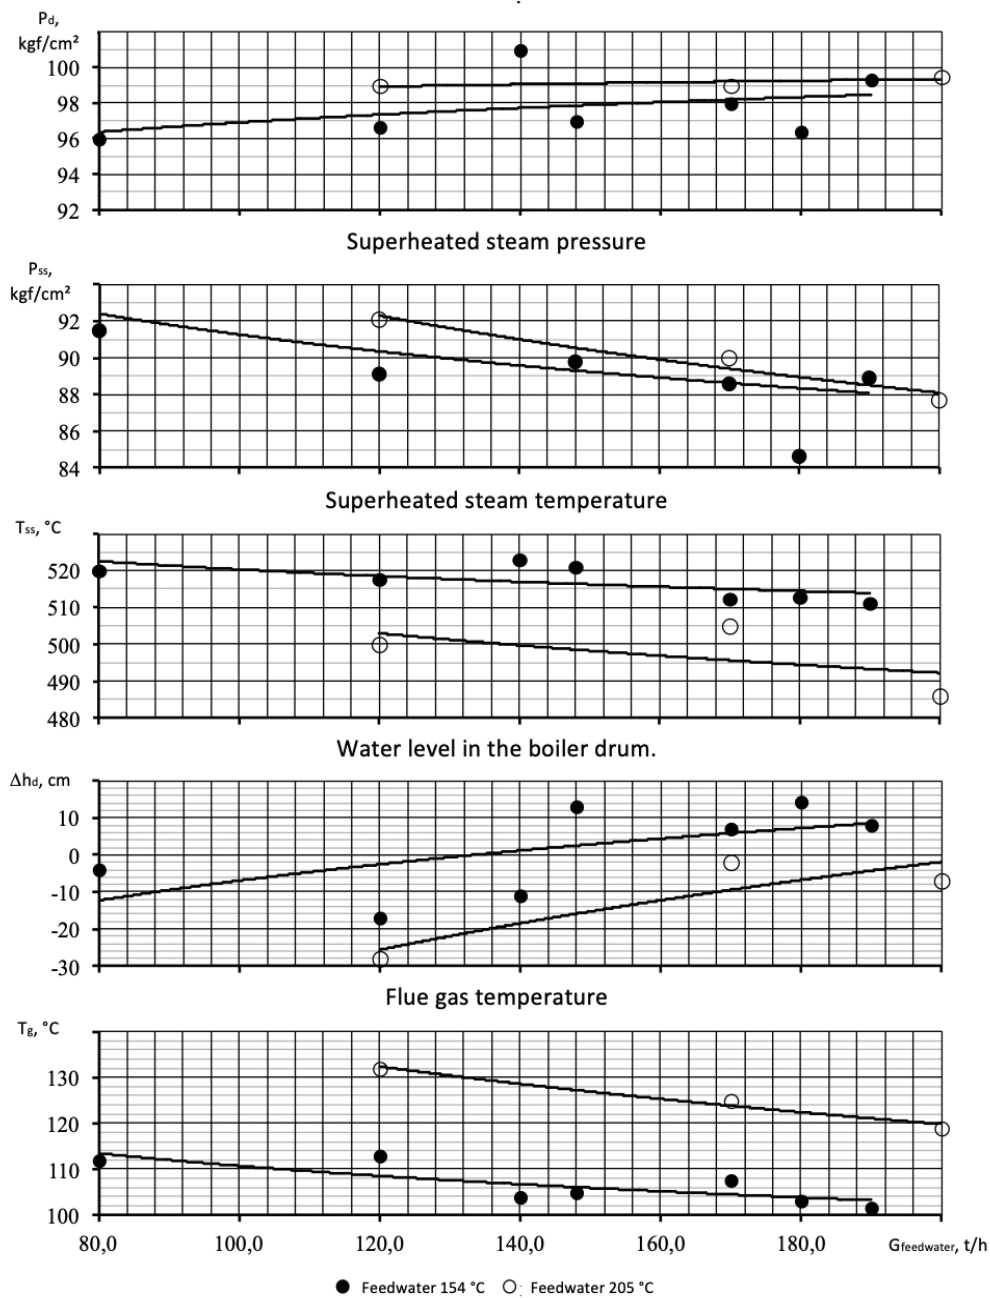
Figure 1 presents the test results of the boiler in the load range of 190-200 t/h. From the figure, it can be seen that circulation velocities slightly increase with the load, from 1.0 m/s at a load of 120 t/h to 1.3 m/s at a load of 200 t/h, and their values practically correspond to the calculated values.

Figure 1: Main parameters of the boiler and circulation velocities with changes in boiler load Boiler drum pressure.

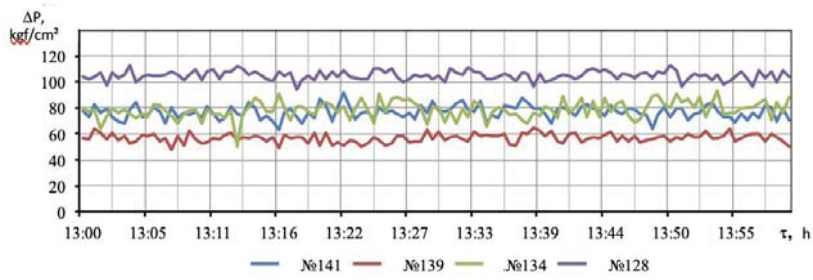
Pitot tubes at a load of 190 t/h, indicating that circulation velocities have minor structural pulsations and exhibit a stable character.

Figure 2: Dynamic pressure of Pitot tubes at a boiler load of 190 t/h and feedwater temperature of 205 °C.

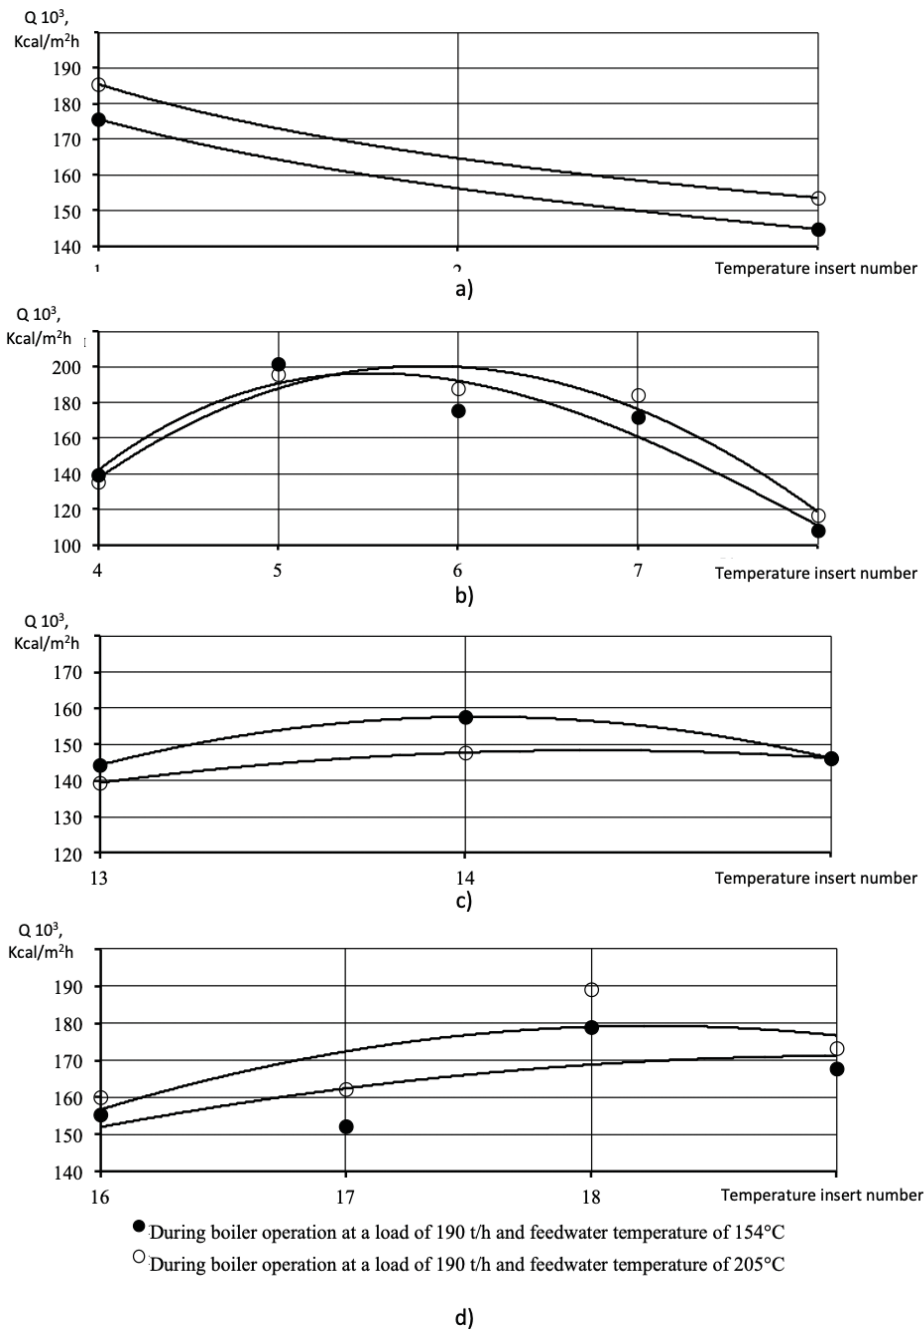
As seen in Figure 3, which illustrates the distribution of heat flows across the width of the left side screen, the maximum heat flows do not exceed 200,000 kcal/m²h. At such heat load values and measured circulation velocities, the occurrence of critical deterioration of heat transfer in the screen tubes is excluded, which is confirmed by temperature measurements on the outer surface of the screen tubes, with values not exceeding 330 °C - 345 °C.

Figure 3: Distribution of heat loads across the width of the furnace at an elevation of 8.0 m. a) Front screen; b) Right side screen; c) Rear screen; d) Left side screen.

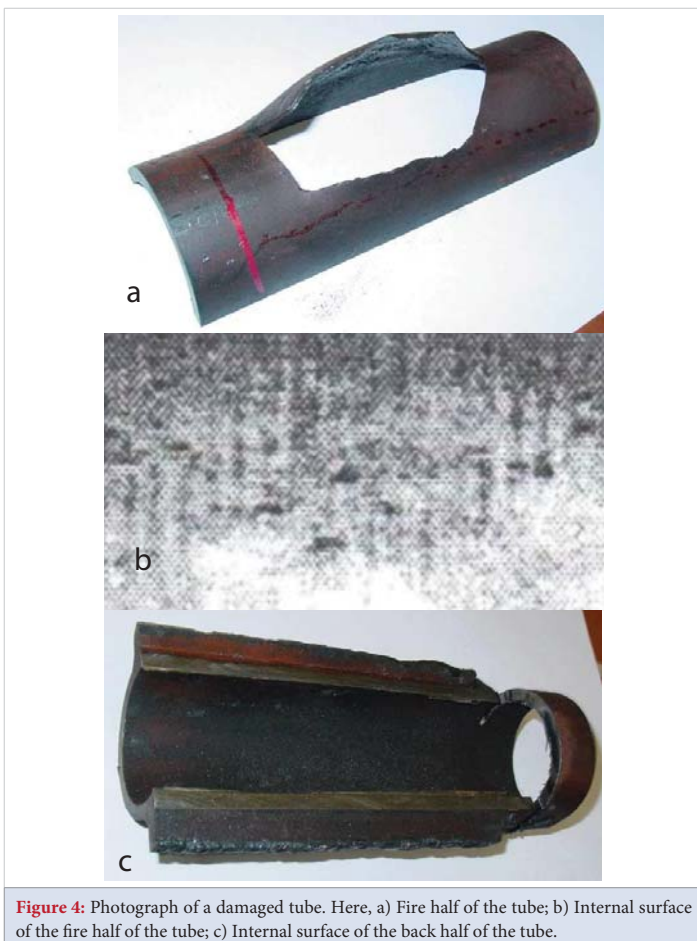
Figure 4 presents photographs of the damaged screen tube. The damage is characterized by metal rupture on the heated side. On the internal fire side of the tube, the damaged metal is subject to significant corrosion. Traces of point corrosion, in the form of ulcers with a diameter of 1.2 mm - 3 mm and a depth of no more than 0.5 mm, are observed on the internal surface of the back side of the tube.

On the internal surface of the fire half of the tube, there are dense black deposits, amounting to 176 g/m², determined by the cathodic etching method and consisting mainly of iron oxides (75% - 90% Fe₂O₃). Significant losses during annealing (up to 8%) are noted.

Figure 4: Photograph of a damaged tube. Here, a) Fire half of the tube; b) Internal surface of the fire half of the tube; c) Internal surface of the back half of the tube.

Internal deposits on the fire side of the tube are solid and practically cannot be removed by mechanical means, while on the back side, they are loose and easily removable by mechanical scraping.

The formation of numerous leaks, in the form of through holes with a diameter of 0.5mm - 1.0 mm, is caused by internal corrosion of the metal due to the destruction of the protective film, resulting from the impact of aggressive boiler water. Metal overheating in the area of leaks is not observed.

The main cause of metal ruptures in the screen tube (Figure 3a), with dimensions of 120x40 mm, is metal corrosion, as well as local overheating of the wall caused by the formation of a steam layer due to the detachment of internal deposits.

Due to the difference in thermophysical properties between changed deposits and tube metal, their delamination occurred, creating a steam layer at the tube wall, where deep evaporation of salts and intensified corrosion, as well as metal overheating, took place. It is worth noting that similar types of screen tube damage were observed in boilers with direct combustion.

Therefore, a replacement of screen tubes was carried out on both side screens, totaling 14 tubes.

After the replacement of the screen tubes, no damages were observed on the reconstructed boilers.
