Investigation of Lateral Vibrations in Turbine-generator Unit 5 of the Inga 2 Hydroelectric Power Plant

The article presents a case study on the Investigation of lateral vibrations in the turbine-generator unit 5 of the Inga 2 hydroelectric power plant in the Democratic Republic of the Congo. Lateral vibrations were experimentally determined using twelve proximity and eddy-current probes, positioned on each measurement plane. The results were analyzed using the DasyLab and R software. Hence, it was observed that the vibration amplitudes of the upper guide bearing, lower guide bearing, and pivot/rotor exceeded acceptable or critical limit values of the international vibration standard for a rotating speed between 100-250 rpm. These excesses can lead to rotor mass imbalances, the eccentricity of the rotor axis relative to the rotation axis of the shaft, and the deformation of the coupling shaft between the upper rotor shaft and the turbine rotor shaft. Subsequently, the means and the variances of the vibration amplitudes were evaluated and compared to the reference values of the international standard. The results of the compliance analysis revealed statistically significant differe

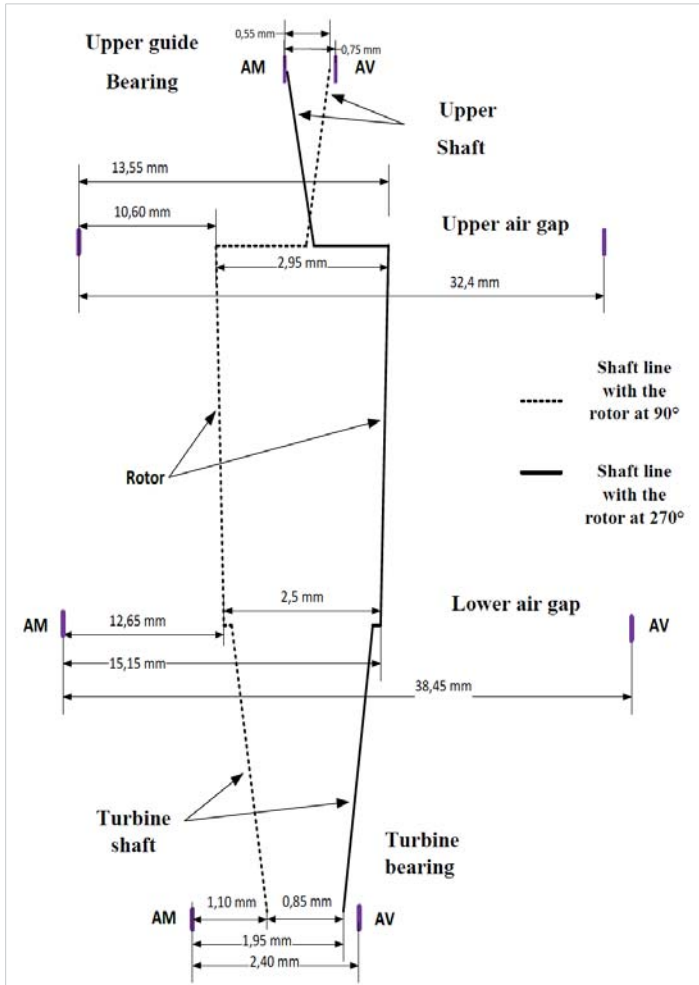
Figure 2: Shaft lines along the upstream-downstream axis.

Based on the two presented graphs, the following phenomena were observed in the turbine-generator unit 5 at Inga 2:

- Shaft fractures in top shaft-rotor and turbine shaft-rotor couplings;
- Strong eccentricity of the rotor axis concerning the axis of rotation of the shaft line;
- On these graphs, only the minimum values recorded on each measurement plane are shown, to illustrate the most unfavorable static positions of the shaft line;
- The clearances in the guide bearings also represent the maximum lateral displacements that the shaft line will be able to perform dynamically;
- These graphs represent the section of the shaft line

These data, once the characteristic vibration frequency (1x) of the recorded vibration signals in static conditions, are as follows on the pivot/rotor: 3,15 mm for the x-axis, 1,45 mm for y-axis; upper rotor: 2,5 mm for x-axis, 2,00 mm for y-axis; upper guide bearing: 0,7 mm for x-axis, 0,55 mm for y-axis lower guide bearing: 0,85 mm for x-axis, 0,45 mm for y-axis. In transient conditions (star, the values are presented in Table 4 and shown in Figure 4 for the last two start-ups performed.

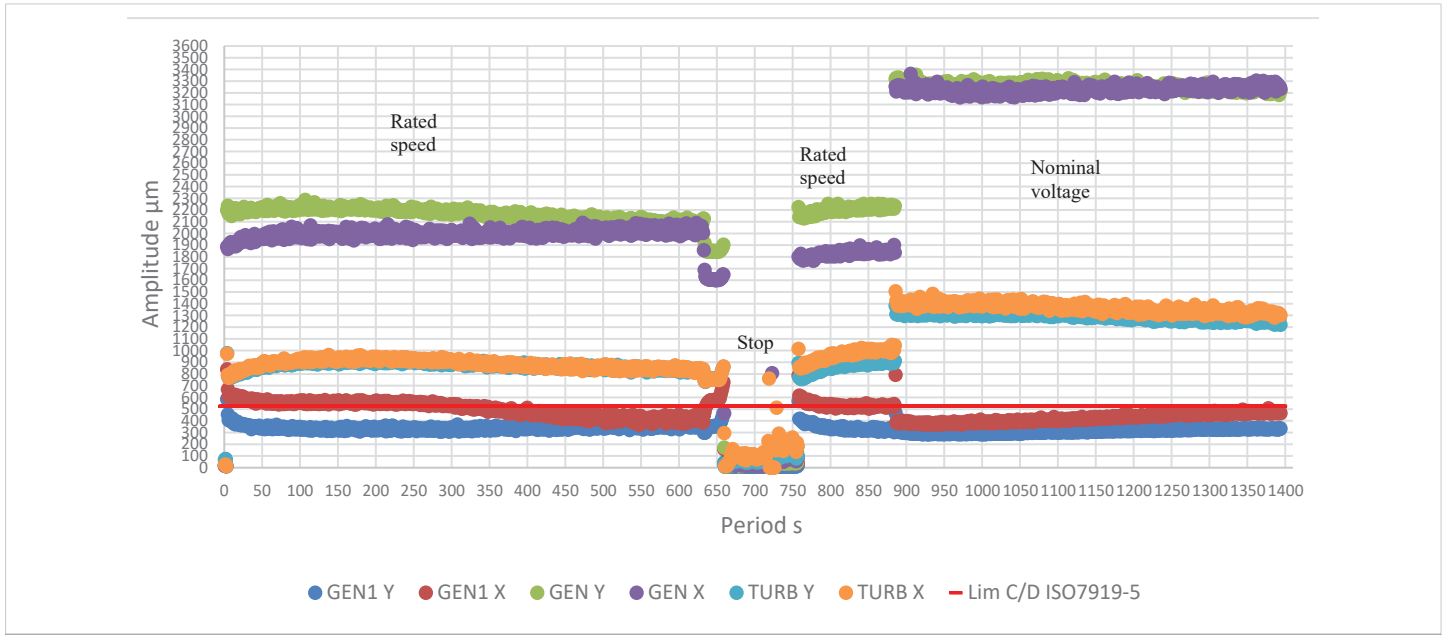
Figure 4: Evolution (cloud) of the overall (peak-to-peak) displacement values for the last two tart-ups (06/07).

The nominal voltage stage in Figure 4 has a larger amplitude value compared to the rated speed stage.

The results of the compliance analysis indicated statistically significant deviations between the measured values and the standard values at a 5% significance level and a rotational speed of 107,1 rpm [16] of the turbine generator unit 5. This indicates that the lateral vibrations exceed the specified limits in the standard in Tables 5-8.
