Investigation of Lateral Vibrations in Turbine-generator Unit 5 of the Inga 2 Hydroelectric Power Plant

The article presents a case study on the Investigation of lateral vibrations in the turbine-generator unit 5 of the Inga 2 hydroelectric power plant in the Democratic Republic of the Congo. Lateral vibrations were experimentally determined using twelve proximity and eddy-current probes, positioned on each measurement plane. The results were analyzed using the DasyLab and R software. Hence, it was observed that the vibration amplitudes of the upper guide bearing, lower guide bearing, and pivot/rotor exceeded acceptable or critical limit values of the international vibration standard for a rotating speed between 100-250 rpm. These excesses can lead to rotor mass imbalances, the eccentricity of the rotor axis relative to the rotation axis of the shaft, and the deformation of the coupling shaft between the upper rotor shaft and the turbine rotor shaft. Subsequently, the means and the variances of the vibration amplitudes were evaluated and compared to the reference values of the international standard. The results of the compliance analysis revealed statistically significant differe

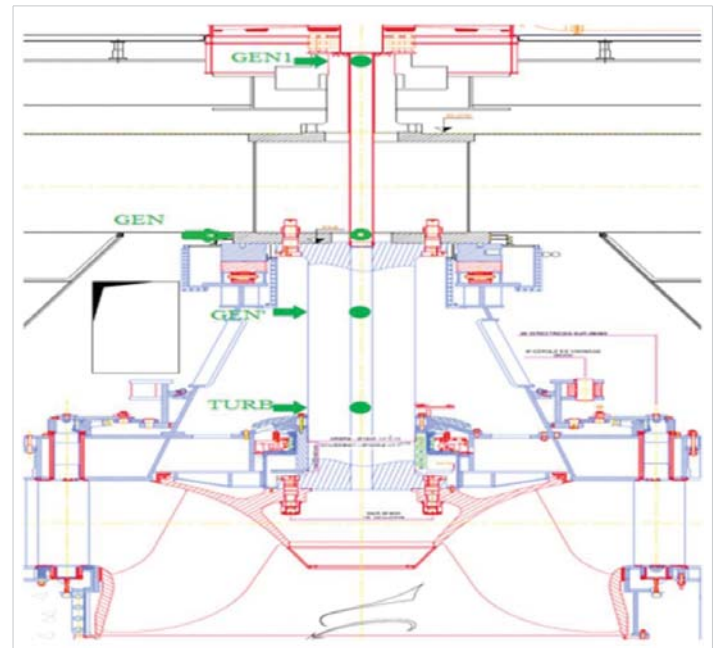
Using four measurement planes to record lateral displacements of the shaft line using proximity probes in hydroelectric group 5 (Figure 1), namely:

- Plane 01 (upper guide bearing): GEN1;
- Plane 02 (Pivot/Rotor): GEN;
- Plane 02' (Pivot/shaft): GEN';
- Plane 03 (lower guide bearing): TURB.

Figure 1: Sensor location on each measurement plane [16].
